RARITAN RIVER BASIN  
NORTH BRANCH RARITAN RIVER  
SOMERSET COUNTY  
NEW JERSEY

# RAVINE LAKE DAM NJ 00362

## PHASE 1 INSPECTION REPORT NATIONAL DAM SAFETY PROGRAM

May, 1979

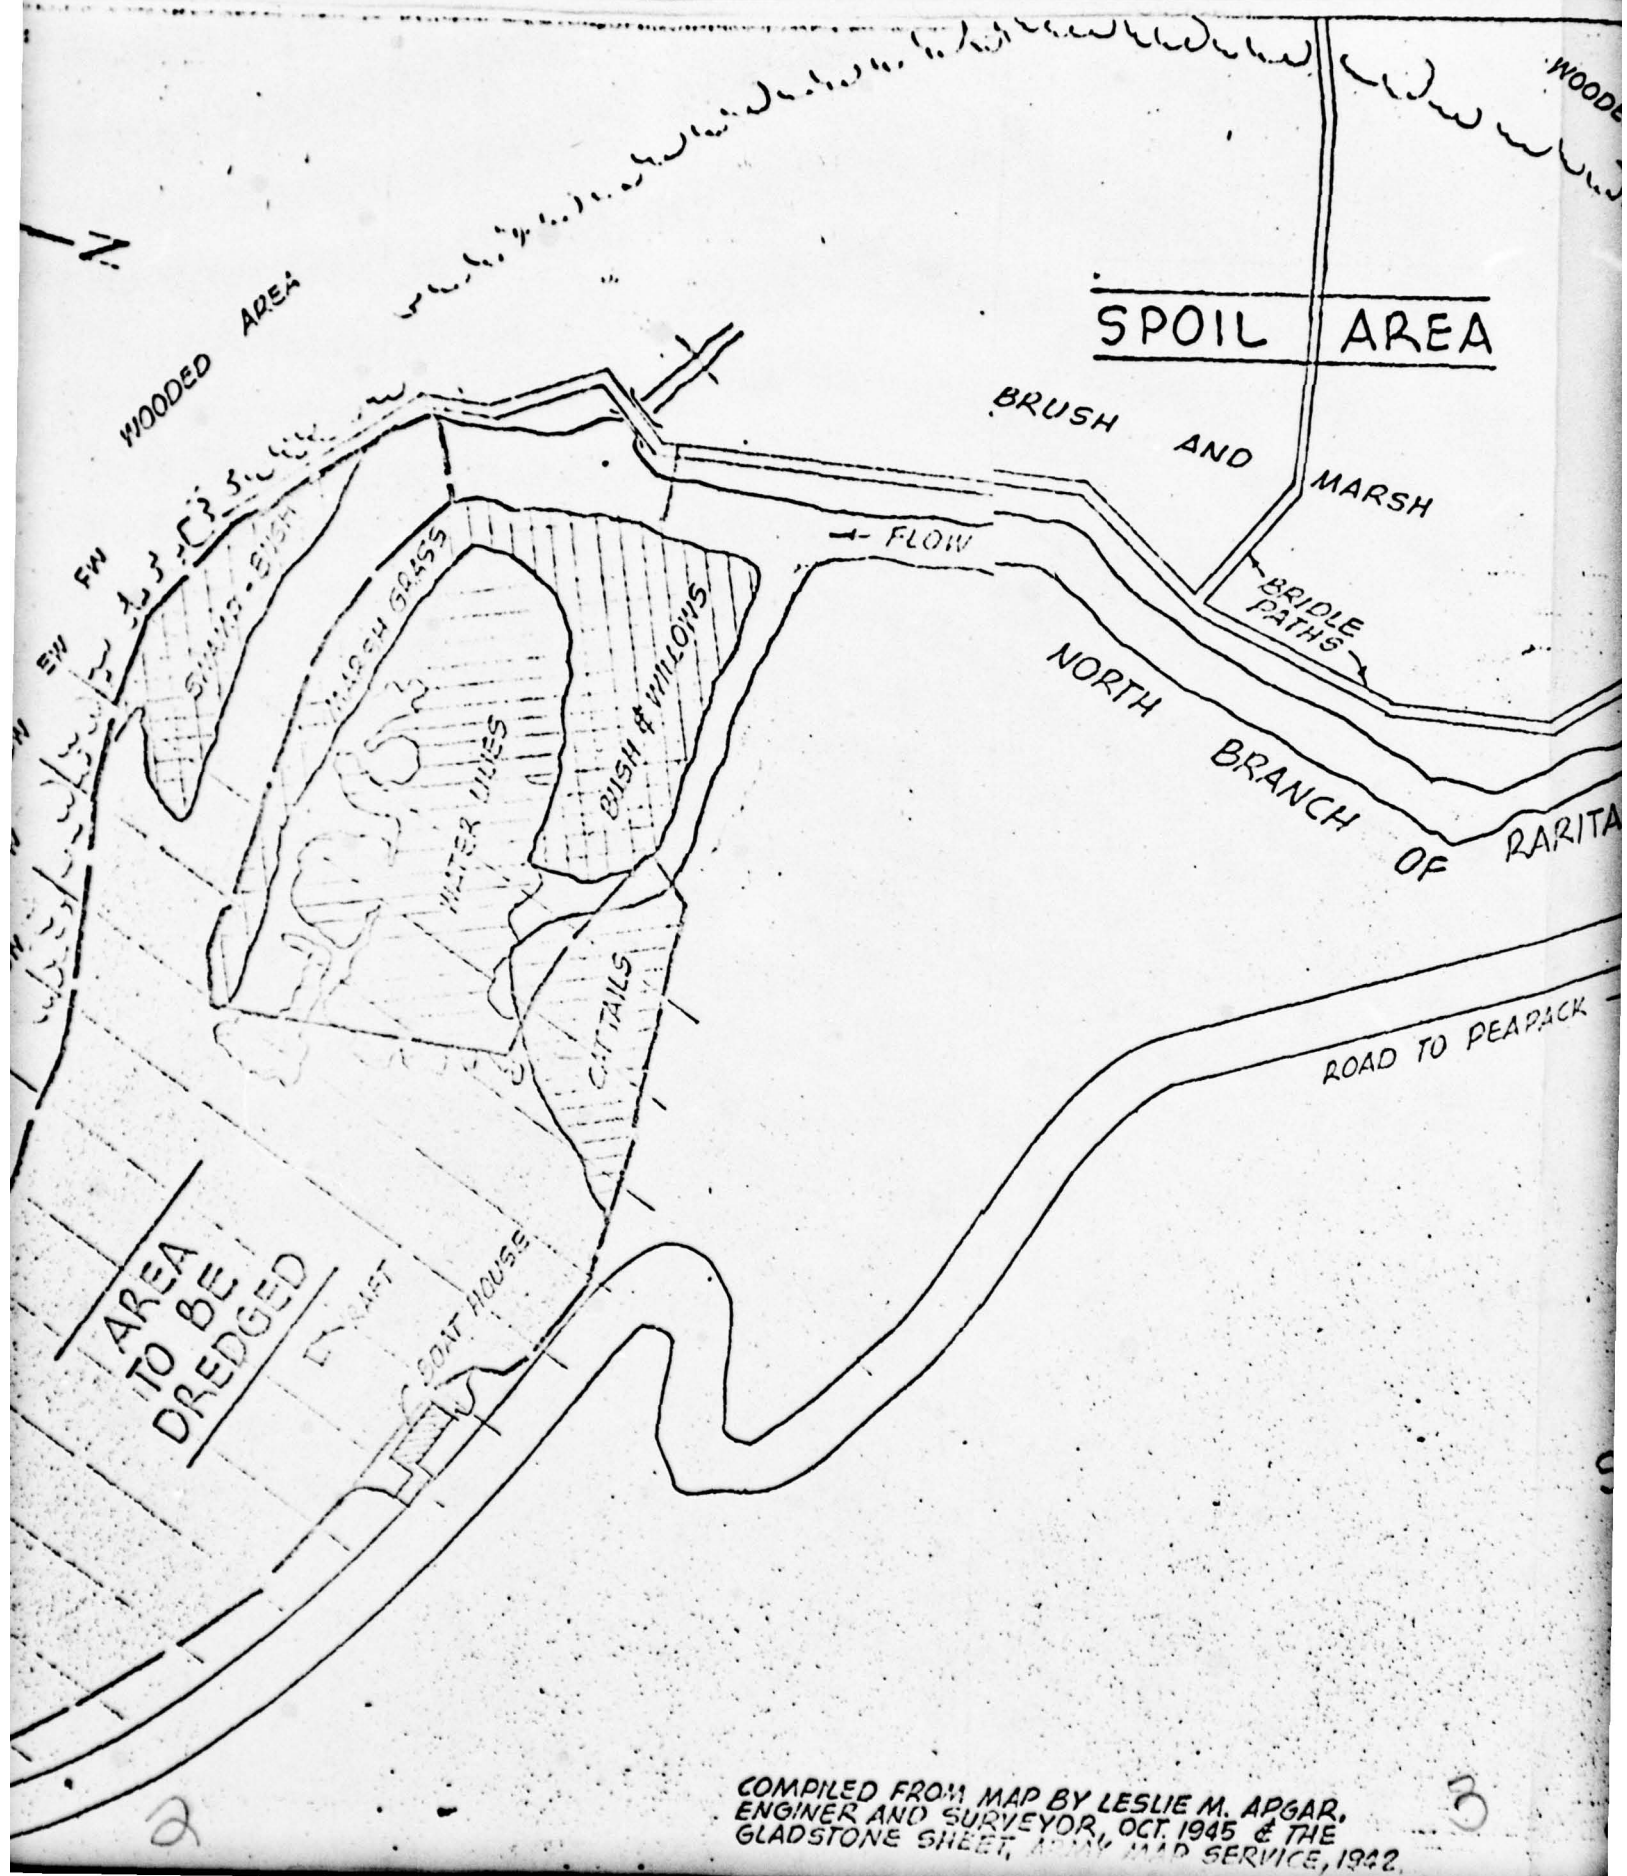
PLATE 4

Siltation has been a problem and as early as 1915 there was an accumulation of 12 feet of sediments behind the dam (see Appendix D, de B. Parsons report). The upper end of the lake was apparently dredged in about 1949 (Plate 4). The present depth of sediments behind the dam is not known.
